doors & hardware

Secure Connections

Choosing the Wrong Fastener Can Have Catastrophic Consequences

By Gregg Melvin and
Michael Chusid, RA, FCSI

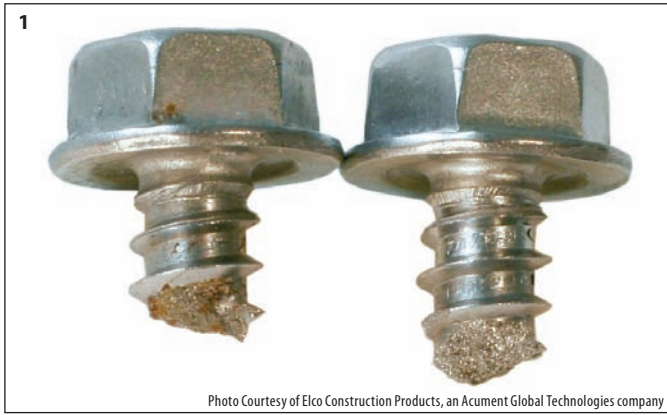
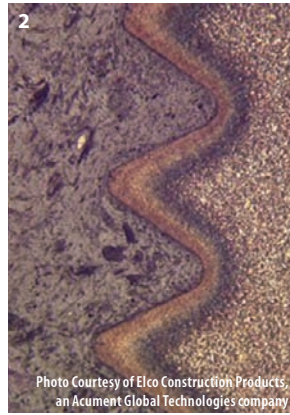
1. Made of case-hardened 410 stainless steel, these self-drilling screws were used to attach aluminum to steel. They failed at the place where the screw shank was aligned with the interface between the two metals. Hydrogen generated by galvanic reaction at that interface caused embrittlement of the hardened casing of the screws.

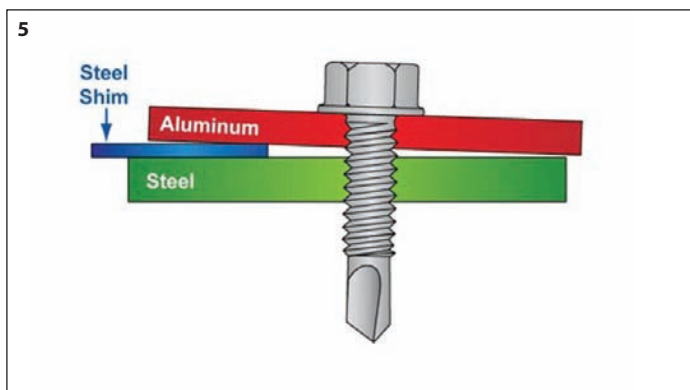
5. Hydrogen embrittlement concentrates at stress points in metal. This test setup for susceptibility to embrittlement failure induces stress in the test fastener in a way that mimics the type of loading often applied in real-world installations: screws are seldom inserted at perfect right angles, placing uneven stress on the screw head. The test screw is engaged through an aluminum plate, into a steel plate. When the screw is tightened, the steel shim puts the fastener in tension slightly off-axis. The test setup is then exposed to saltwater for a given period.

A third source of stress results from the practical fact that self-drilling screws are rarely installed at a perfect perpendicular to the surface that they bear on. When the screw is driven at a slight diagonal, one edge engages first, placing uneven stress on the head.

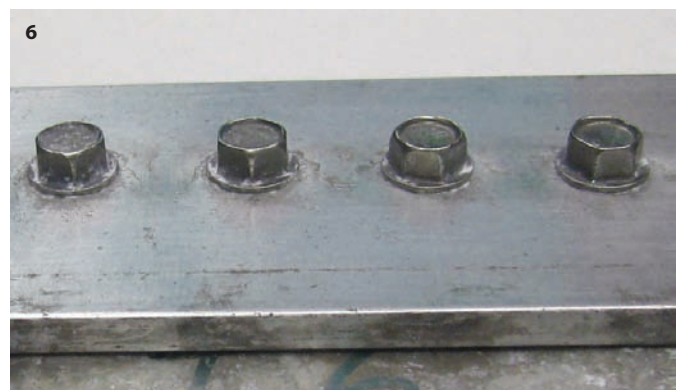
6. Screws in the actual test setup.

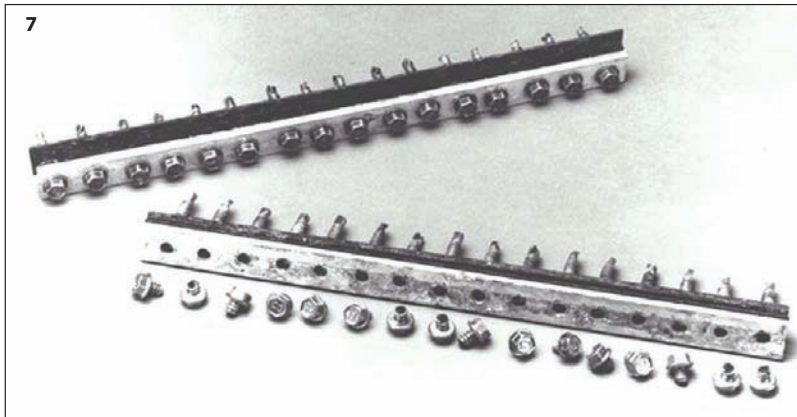
7. After 96 hours of exposure to salt spray, the case-hardened fasteners, in the bottom row, failed. The selectively heat-treated fasteners, in the top row, did not fail.

A fastener can be selectively heat-treated, not case-hardened, so that only the drilling tip and lead threads are hardened. The majority of the shank is softer steel that is

not prone to HASCC. This process uses Grade 5 steel, an alloy that has enough carbon already present to be hardened simply by heating. The tip of the part is passed through an induction coil that heats it and hardens it locally without affecting the rest of the shank.

When a selectively heat-treated fastener is installed, the hardened tip penetrates the anchoring metal and cuts threads in it, but then moves past the connection area as the screw is driven to full depth. The relatively softer steel portion of the shank, which is not vulnerable to HASCC, bears the load. The fastener performs as would a ductile Grade 5 bolt, the same type of bolt used for structural steel connections, assuring a high degree of reliability.

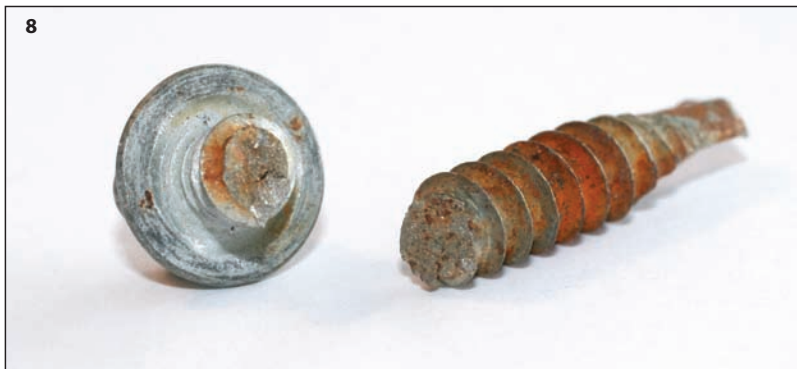
8. The junction of the screw head and shank is a concentration point for both residual stress from the manufacturing process and application induced stress. Hydrogen atoms invade stress points easily, causing HASCC failures.

way in which the screw is typically used. The shape of the screw is made by deforming the metal comprising the head to a diameter as much as 500% wider, causing it to retain residual stress.

Application-induced stress also concentrates at the junction between the screw shank and head. When the screw is driven all the way into the hole, the head is the part that resists further progress, putting it in a constant state of tension.

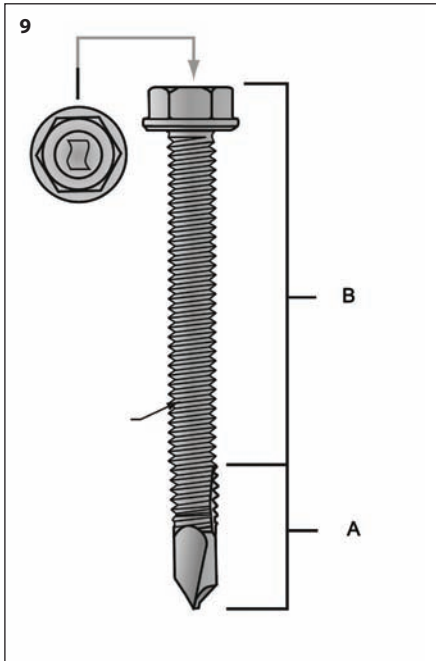
9. Self-drilling fasteners that are resistant to hydrogen assisted stress corrosion cracking have three zones. Section A has to be hard enough to drill into steel and tap threads while Section B has to be strong and ductile enough to carry the intended load. The third section, the head, is marked with an embossment to allow visual identification of an installed fastener's type.

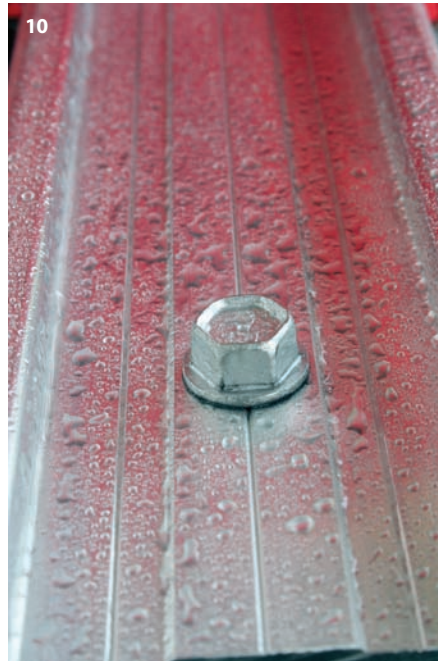
10. For applications where high corrosion-resistance is required, such as installations regularly exposed to moisture, a bi-metal fastener is used so that 300 series stainless steel is exposed to the elements.

Another type of HASCC-resistant fastener is a bi-metal screw, a high-performance part suitable for applications where greater corrosion-resistance is desirable. In this case, a high-carbon steel is used, but only for the drill point and lead threads. The headed shank is made of 300-series stainless steel (also known as 18-8 stainless steel). The two pieces are friction-welded together. Then, the point and lead threads are selectively hardened by induction heating, similarly to the process of heat-treating a selectively hardened carbon steel fastener.

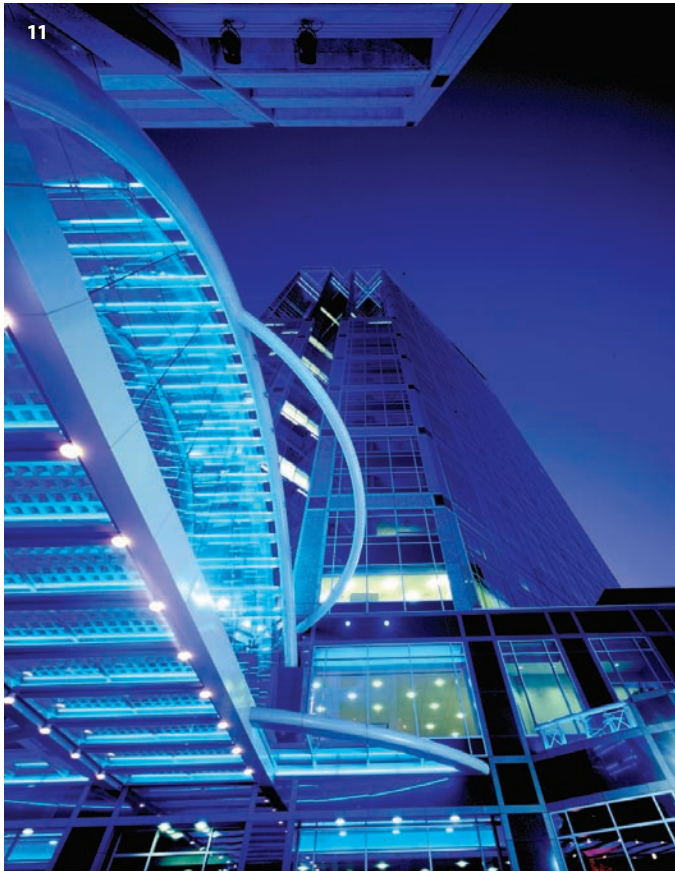
11
Photo ©1998 Wes Thompson, used courtesy of Elco Construction Products, an Acument Global Technologies company

11. Cladding, including glazing units and stone facades, often contain aluminum in the framework that attaches the unit to the building's steel superstructure. This contact of aluminum and steel sets up the risk of galvanic reactions that generate hydrogen and precipitate hydrogen assisted stress corrosion cracking. To preserve the integrity of the cladding's attachment to the building, fasteners that resist hydrogen embrittlement are recommended.

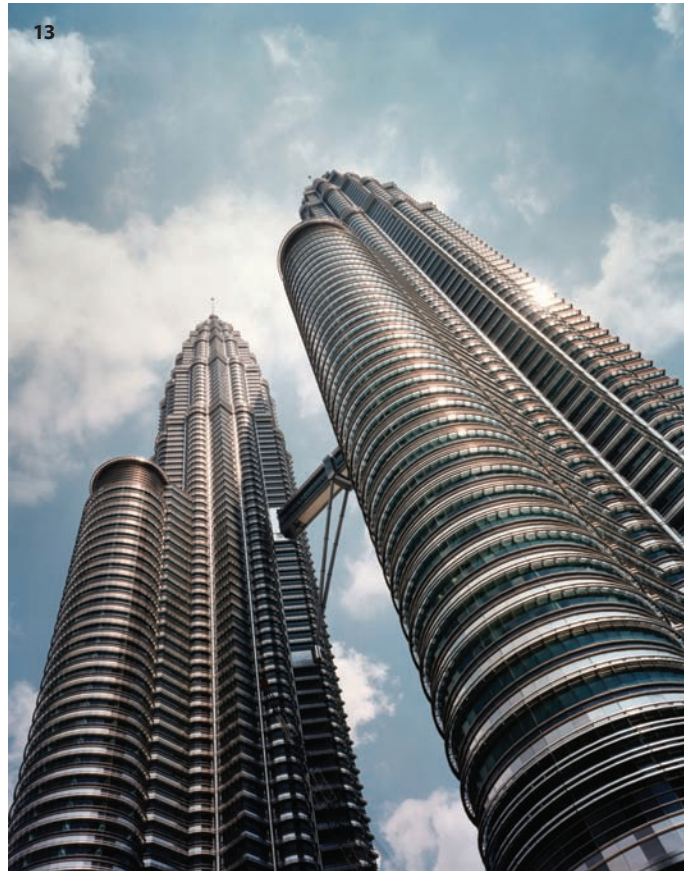
13
Photo ©1998 Wes Thompson, used courtesy of Elco Construction Products, an Acument Global Technologies company

13. The 88-story Petronas Towers in Kuala Lumpur, Malaysia in 1998. The façade contains literally millions of 300 series self-drilling fasteners with multi-layer zinc rich and aluminum-filled coating, chosen to prevent embrittlement from galvanic reaction between steel and aluminum and to mitigate the potential for sacrificial loss of aluminum in the cladding frame system.

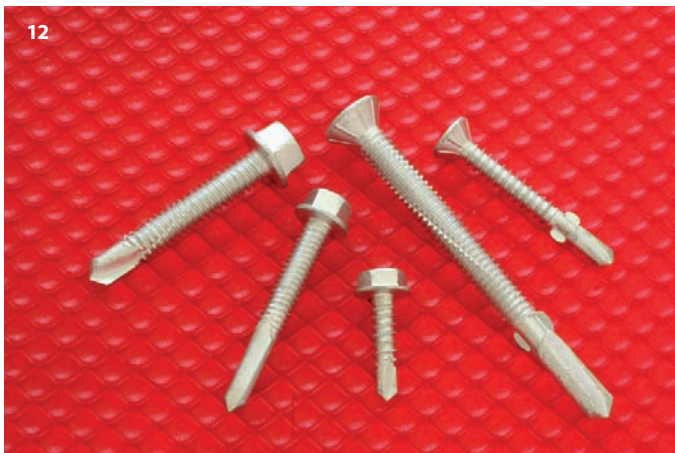
12
Photo ©1998 Wes Thompson, used courtesy of Elco Construction Products, an Acument Global Technologies company

12. Screws resistant to HASCC are available in a wide variety of configurations for applications that include self-drilling and self-tapping in structural steel or in concrete.
